EXPERIMENTAL TESTS FOR THE CHARACTERIZATION OF SISAL FIBER REINFORCED CEMENTITIOUS MATRIX FOR STRENGTHENING MASONRY STRUCTURES

Abstract

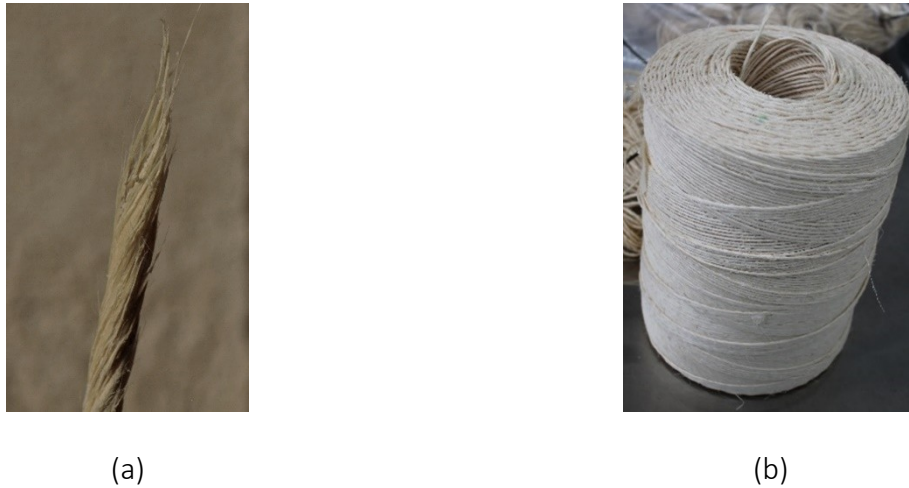
Sisal yarns from Tanzania were used (Fig. 1a). The yarn is composed by twisted filaments of long fibers.

The specimens were obtained by cutting 500 mm length samples from the sisal roll (Fig. 1b). The samples were conditioned 15 days into an alkaline solution with calcium hydroxides and pH 12.5 to stabilize the cellular structure and the tensile response [22].

Fig. 1 Detail of a sisal yarn (a) and yarn roll (b)

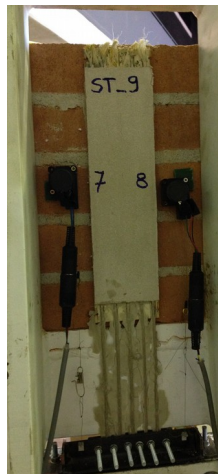
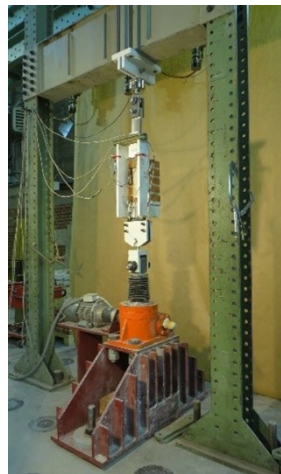
In the University IUAV of Venice laboratory, the tests were carried out with the same testing machine described for tensile tests, under displacement control (Fig. 13 a). A metallic device, shaped as a seat, was used to support the masonry prisms [33]. The device was set so to maintain the yarns in the vertical direction and ensure the vertical alignment of the load along the specimens, taking care to avoid parasitic forces, perpendicular to the masonry surface, which could anticipate the sample failure (Fig. 13 e-f). Two digital transducers were positioned along the specimens to measure the relative displacement between the masonry substrate and the yarns (Fig. 13 b).

The test apparatus of the University of Trieste laboratory (Fig. 13 c-d) was for the most the same of that employed for the tensile tests, but replacing the upper clamps with a metallic device similar to that already described for the setup of the University IUAV of Venice. Two potentiometer transducers measured the displacement between the yarns and the masonry prism. Two adjunctive potentiometer transducers monitored the displacement between the mortar layer and the masonry. However, these potentiometers revealed negligible displacements (< 0.1 mm).

In both laboratories, the yarns extremities were clamped through two metallic plates, coupled with bolts, to avoid the yarns slippage. At the beginning of the tests, the length of unbounded yarns included in the measurement base was $l_d = 160$ mm. A load rate of about 0.6 mm/min (acquisition frequency 5 Hz) was considered.

Fig. 13 Single-lap shear test: University IUAV of Venice test set-up (a) and transducers (b); University of Trieste test set-up (c) and transducers (d); frontal view (e) and lateral section (f) of the test apparatus
